HISTORIC AMERICAN BUILDINGS SURVEY
INVENTORY

2. NAME *Orrin Thompson Mansion*

DATE OR PERIOD *1832*
STYLE *Greek Revival*
ARCHITECT
BUILDER *Orrin Thompson*

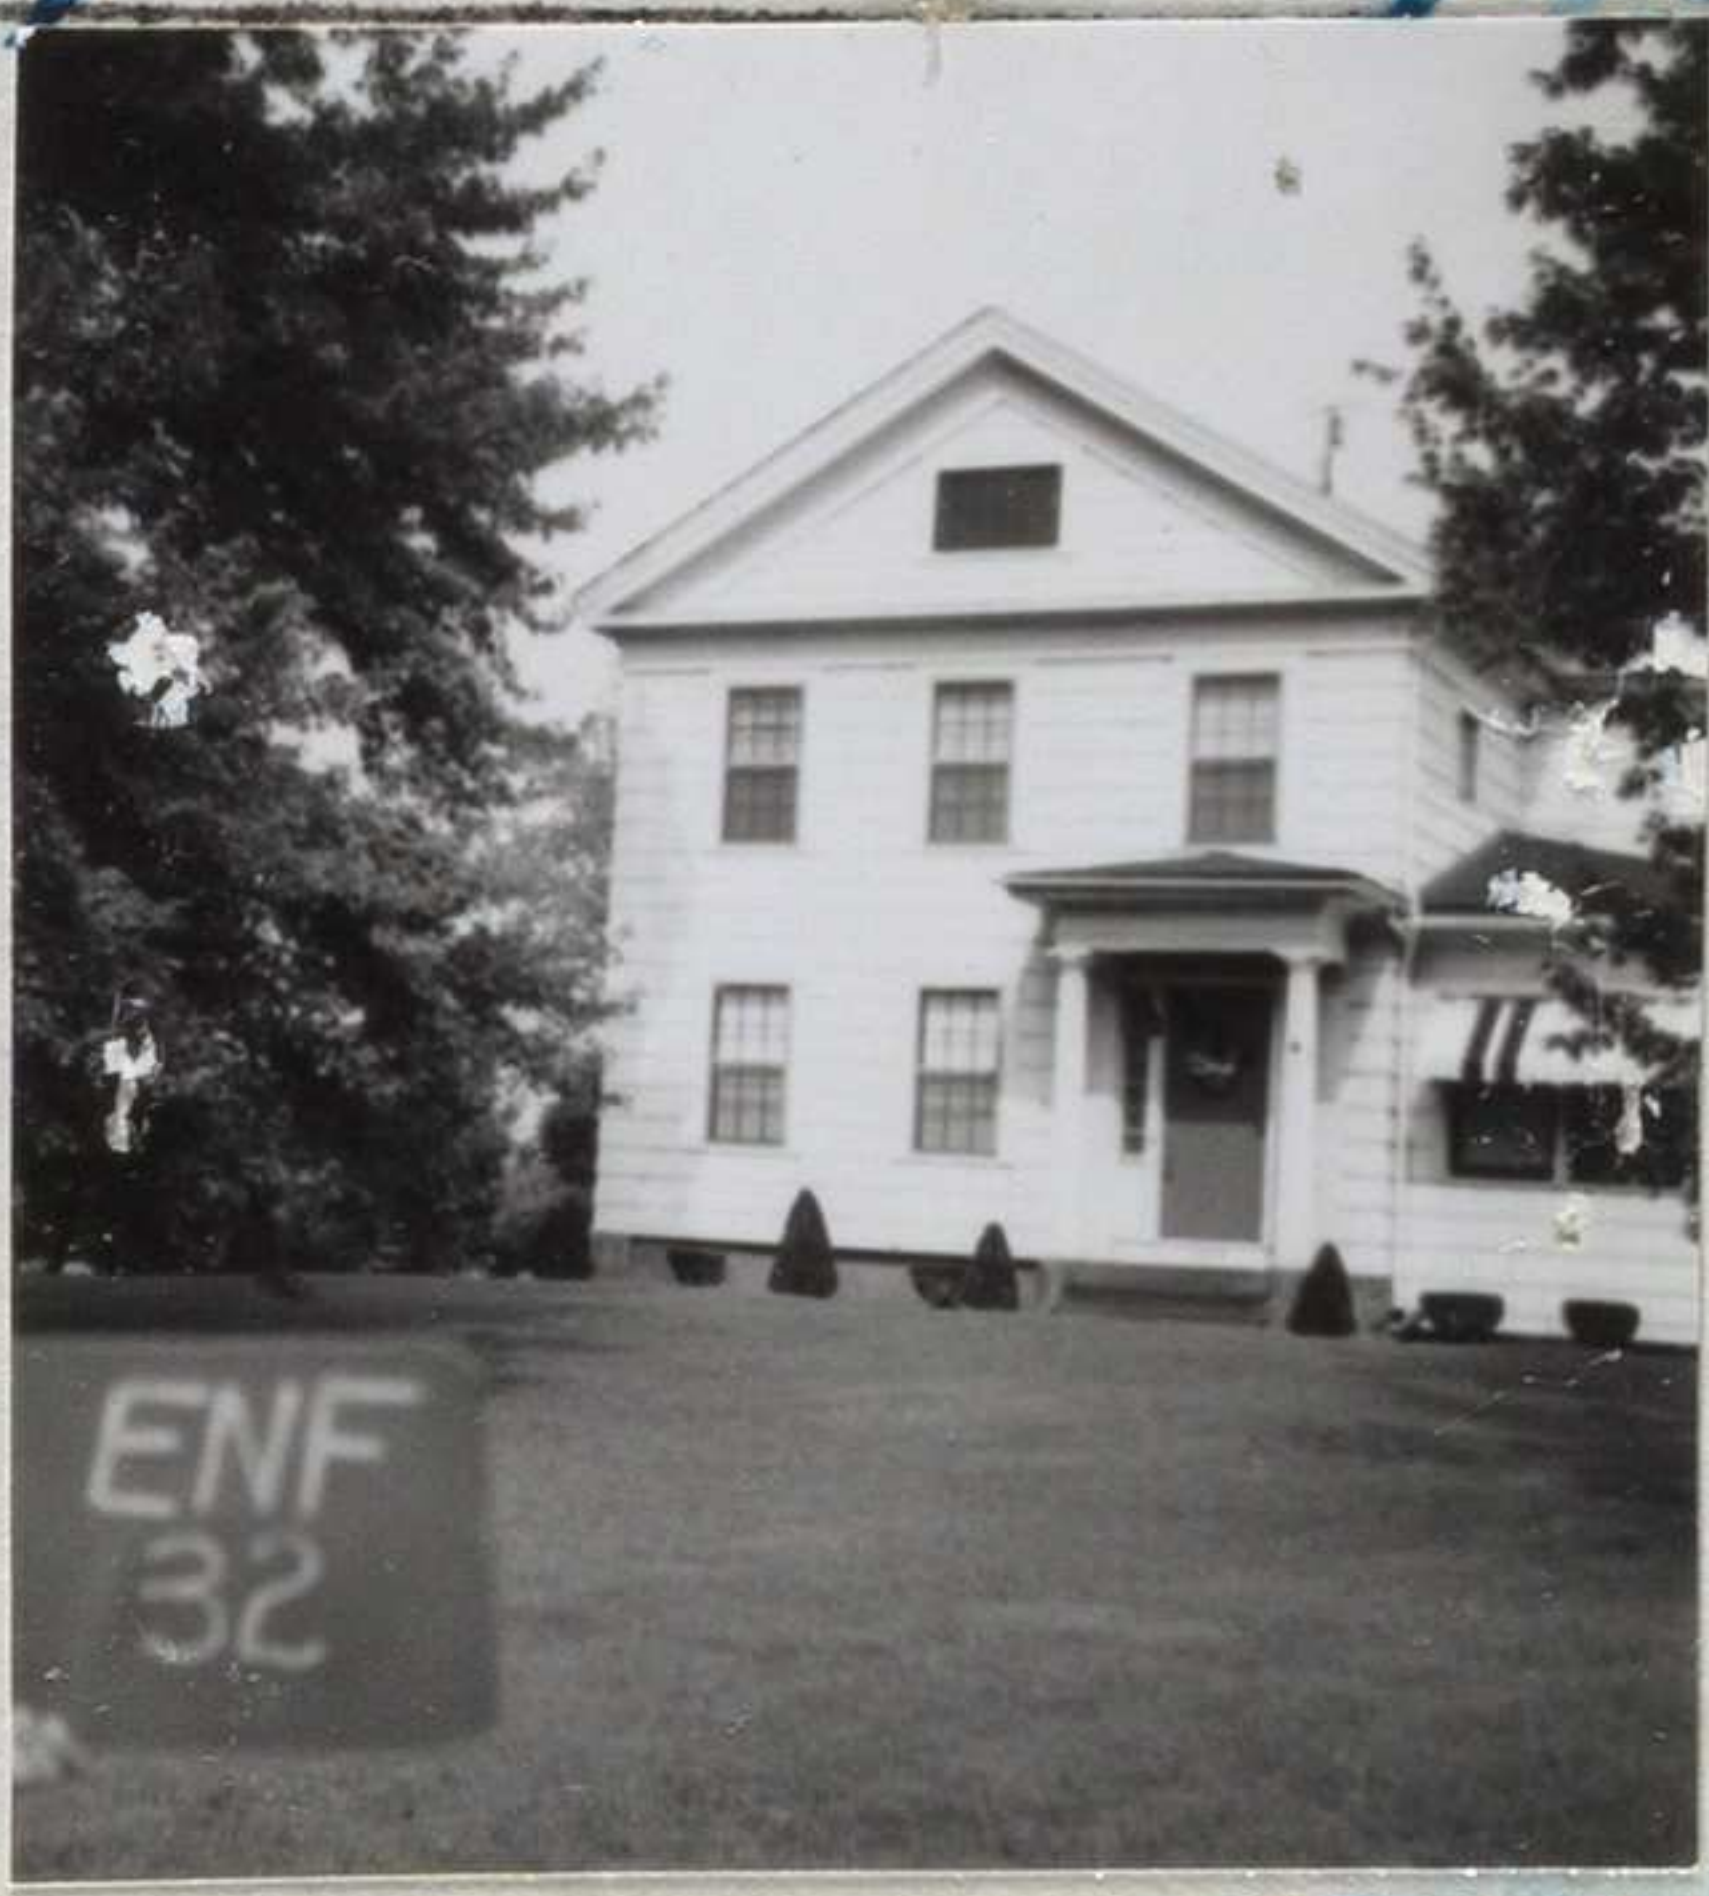
<p>7. PHOTOGRAPH <i>Enf32</i></p>

<p>1. STATE <i>Ct</i> COUNTY <i>Hartford</i> TOWN <i>Enfield</i> VICINITY STREET NO. <i>Enfield St. NE corner of Oliver Rd.</i> ORIGINAL OWNER? ORIGINAL USE <i>Residence</i> PRESENT OWNER? PRESENT USE <i>Residence</i> WALL CONSTRUCTION <i>clapboard</i> NO. OF STORIES <i>2</i></p>		<p>HISTORIC AMERICAN BUILDINGS SURVEY INVENTORY</p>	
		<p>2. NAME DATE OR PERIOD <i>1840</i> STYLE <i>Greek Revival</i> ARCHITECT BUILDER</p>	
		<p>3. FOR LIBRARY OF CONGRESS USE</p>	
<p>4. NOTABLE FEATURES, HISTORICAL SIGNIFICANCE AND DESCRIPTION</p> <p>OPEN TO PUBLIC <i>No.</i></p> <p><i>The shallow pitched roof of this Re- vival house is accented by a strong pediment and centered rectangular windows. Below there are three bays. The door, although not original is framed in a portico with doric columns. The foundation is brick. Numerous extraneous additions have been made.</i></p>			
<p>5. PHYSICAL CONDITION OF STRUCTURE Endangered ? Interior <i>poor</i> Exterior <i>poor</i></p>

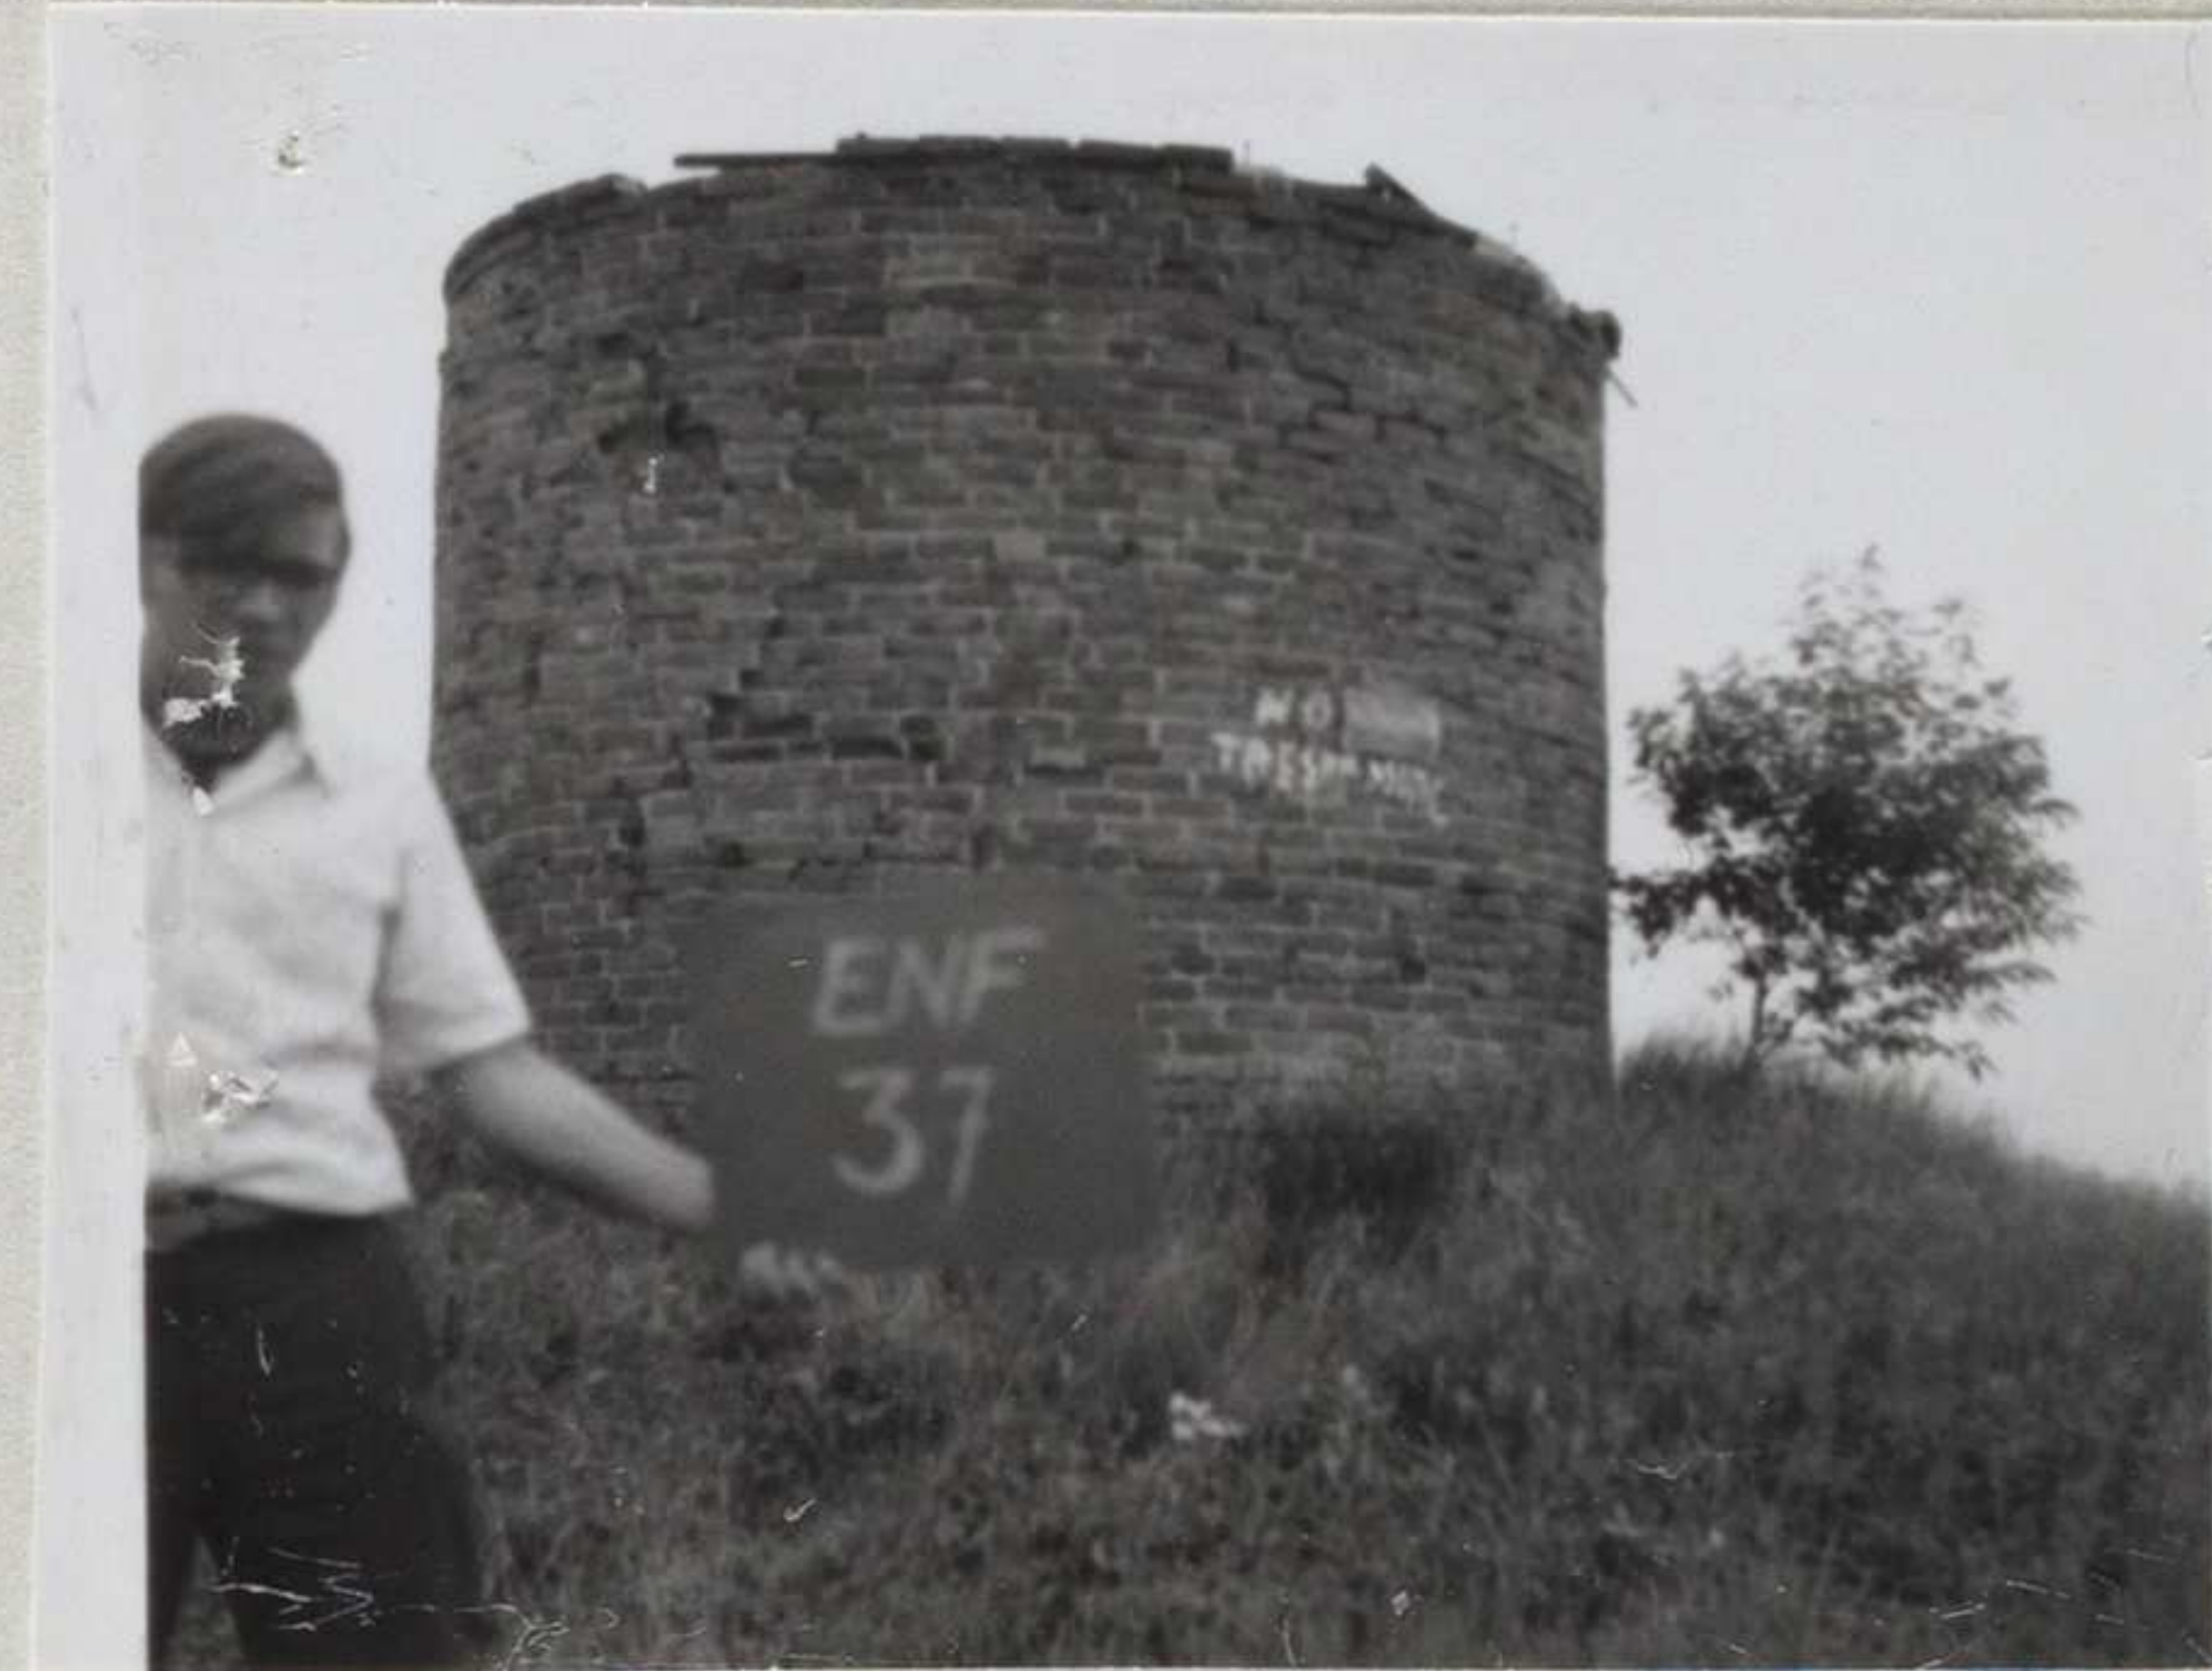
7. PHOTOGRAPH *Enf 37*

Exterior *Fair*

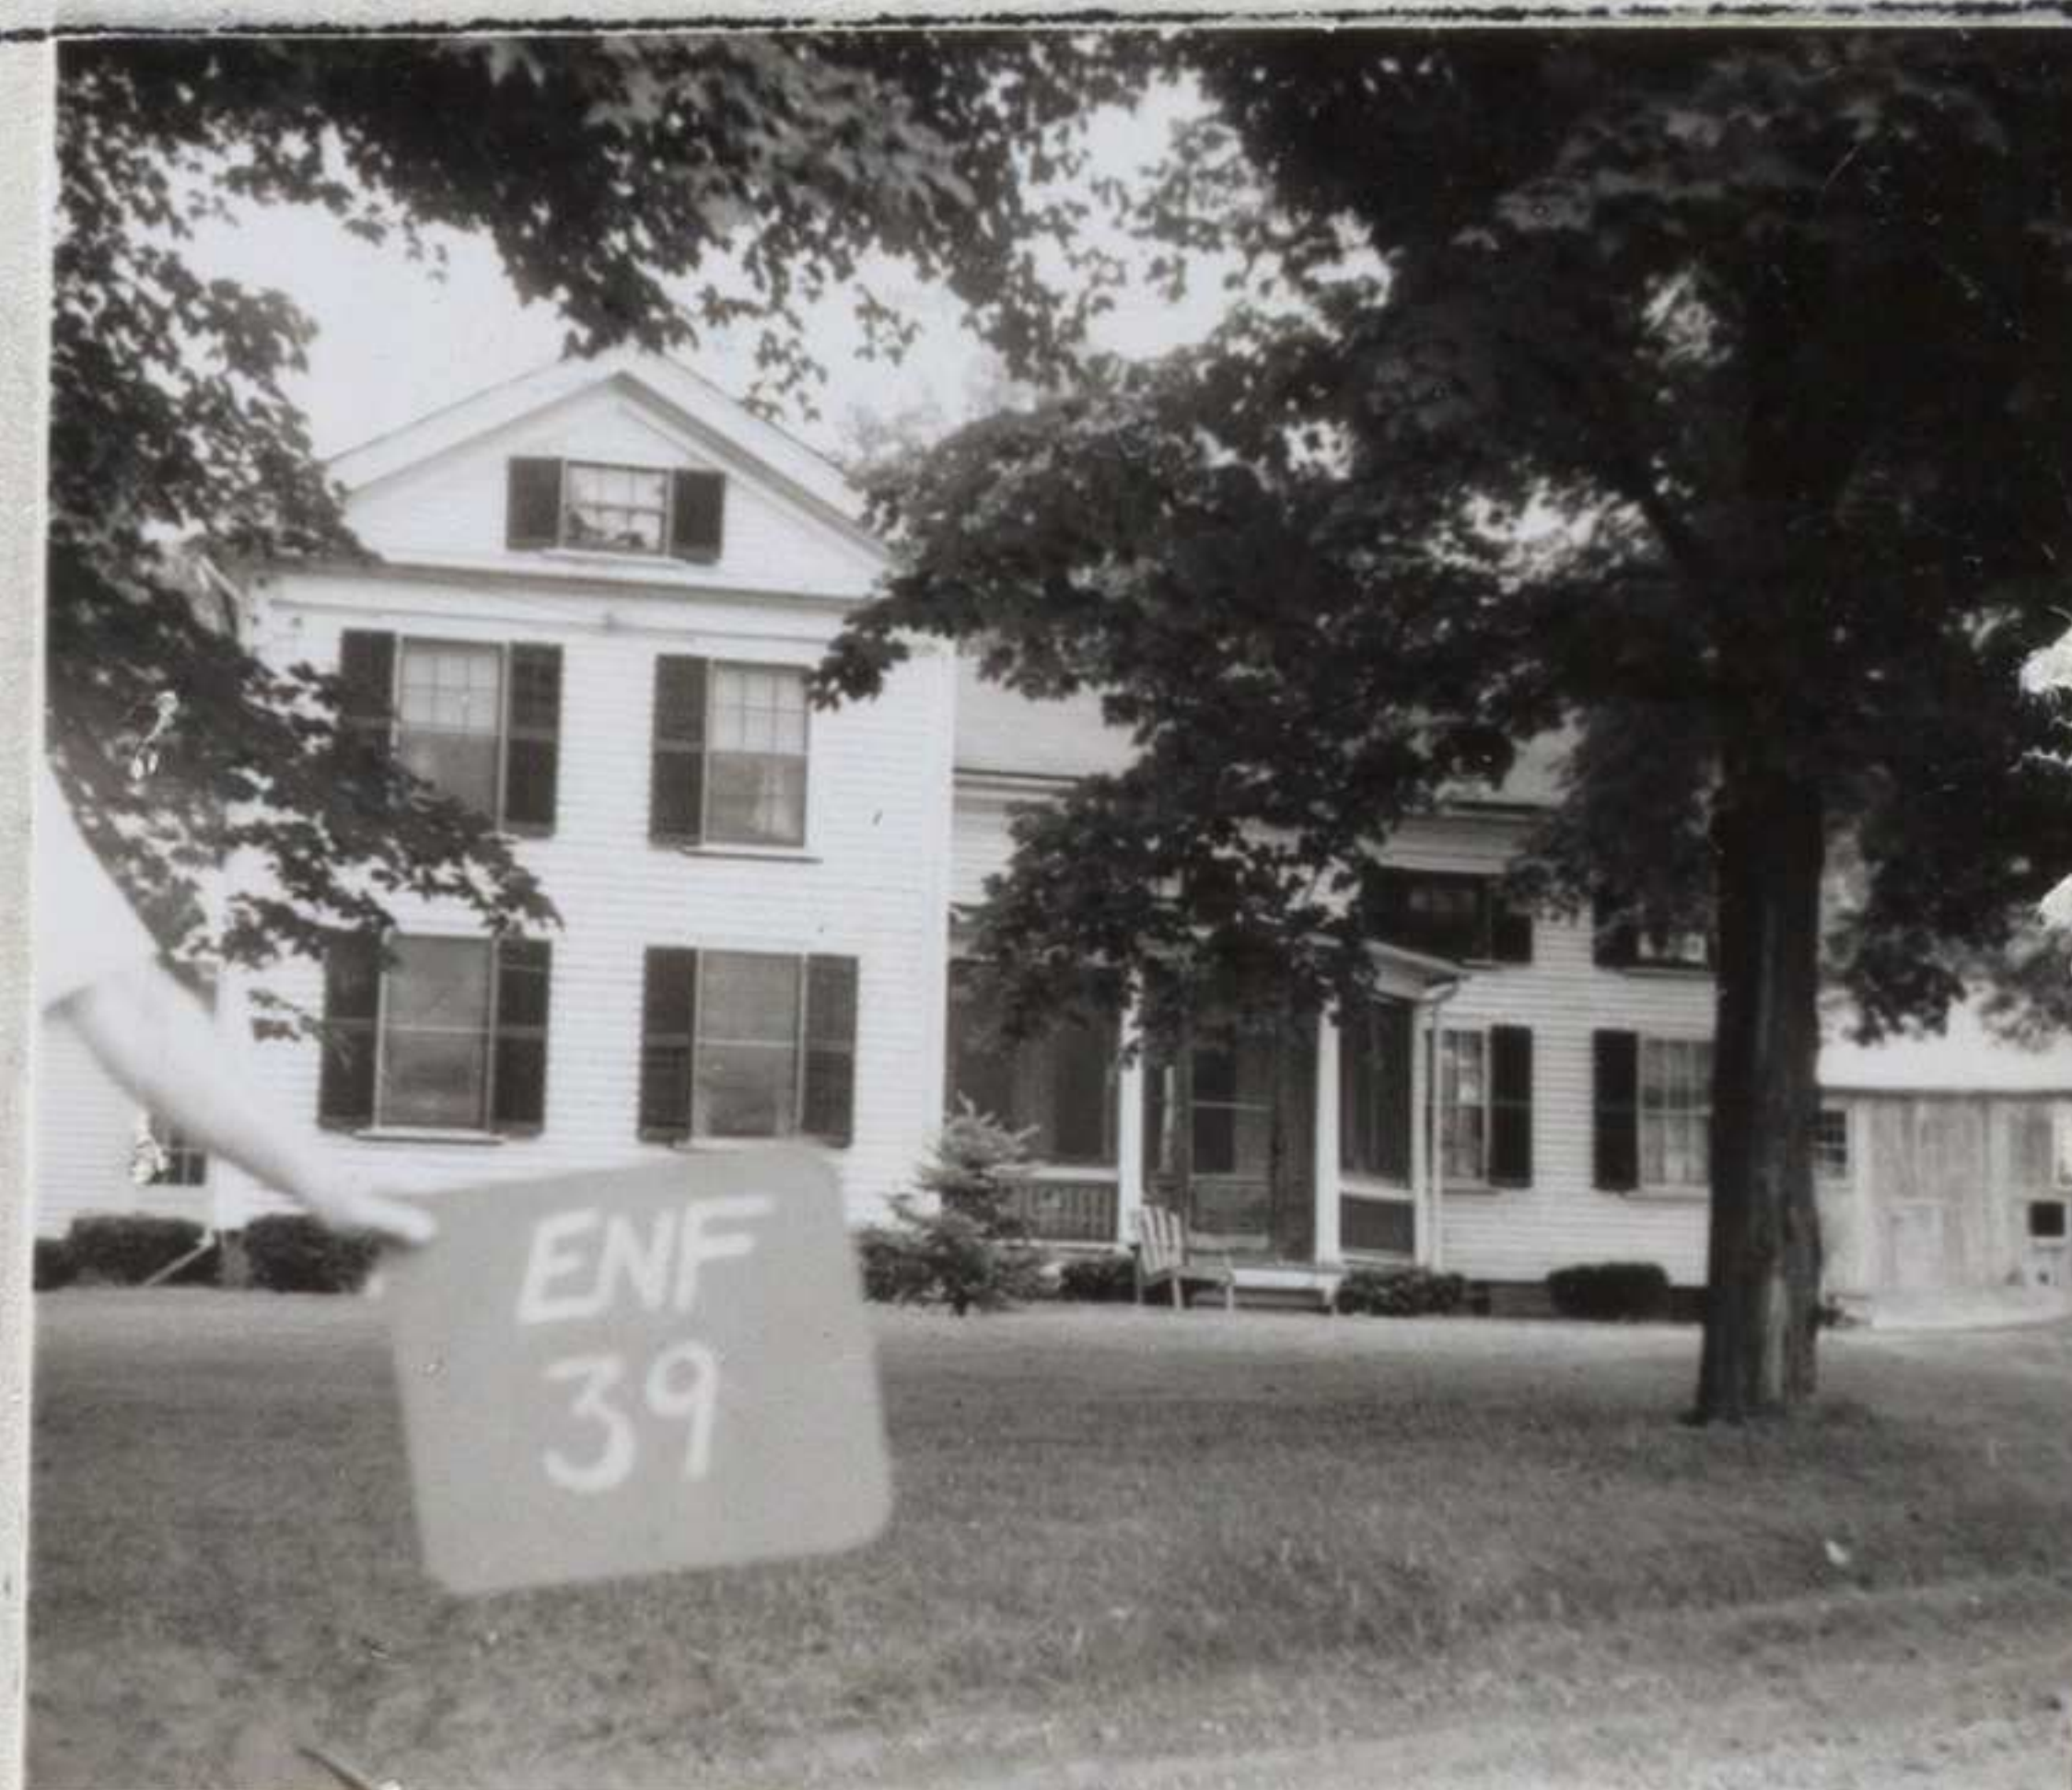
7. PHOTOGRAPHY

The house with its many additions has lost its doorway. The foundation is brick, the roof pitch shallow. The moldings of the accented pediment and window frames are rather fine. To the east of this house is a 1 1/2 story ell.

Endangered *No* Interior *?* Exterior *fair*

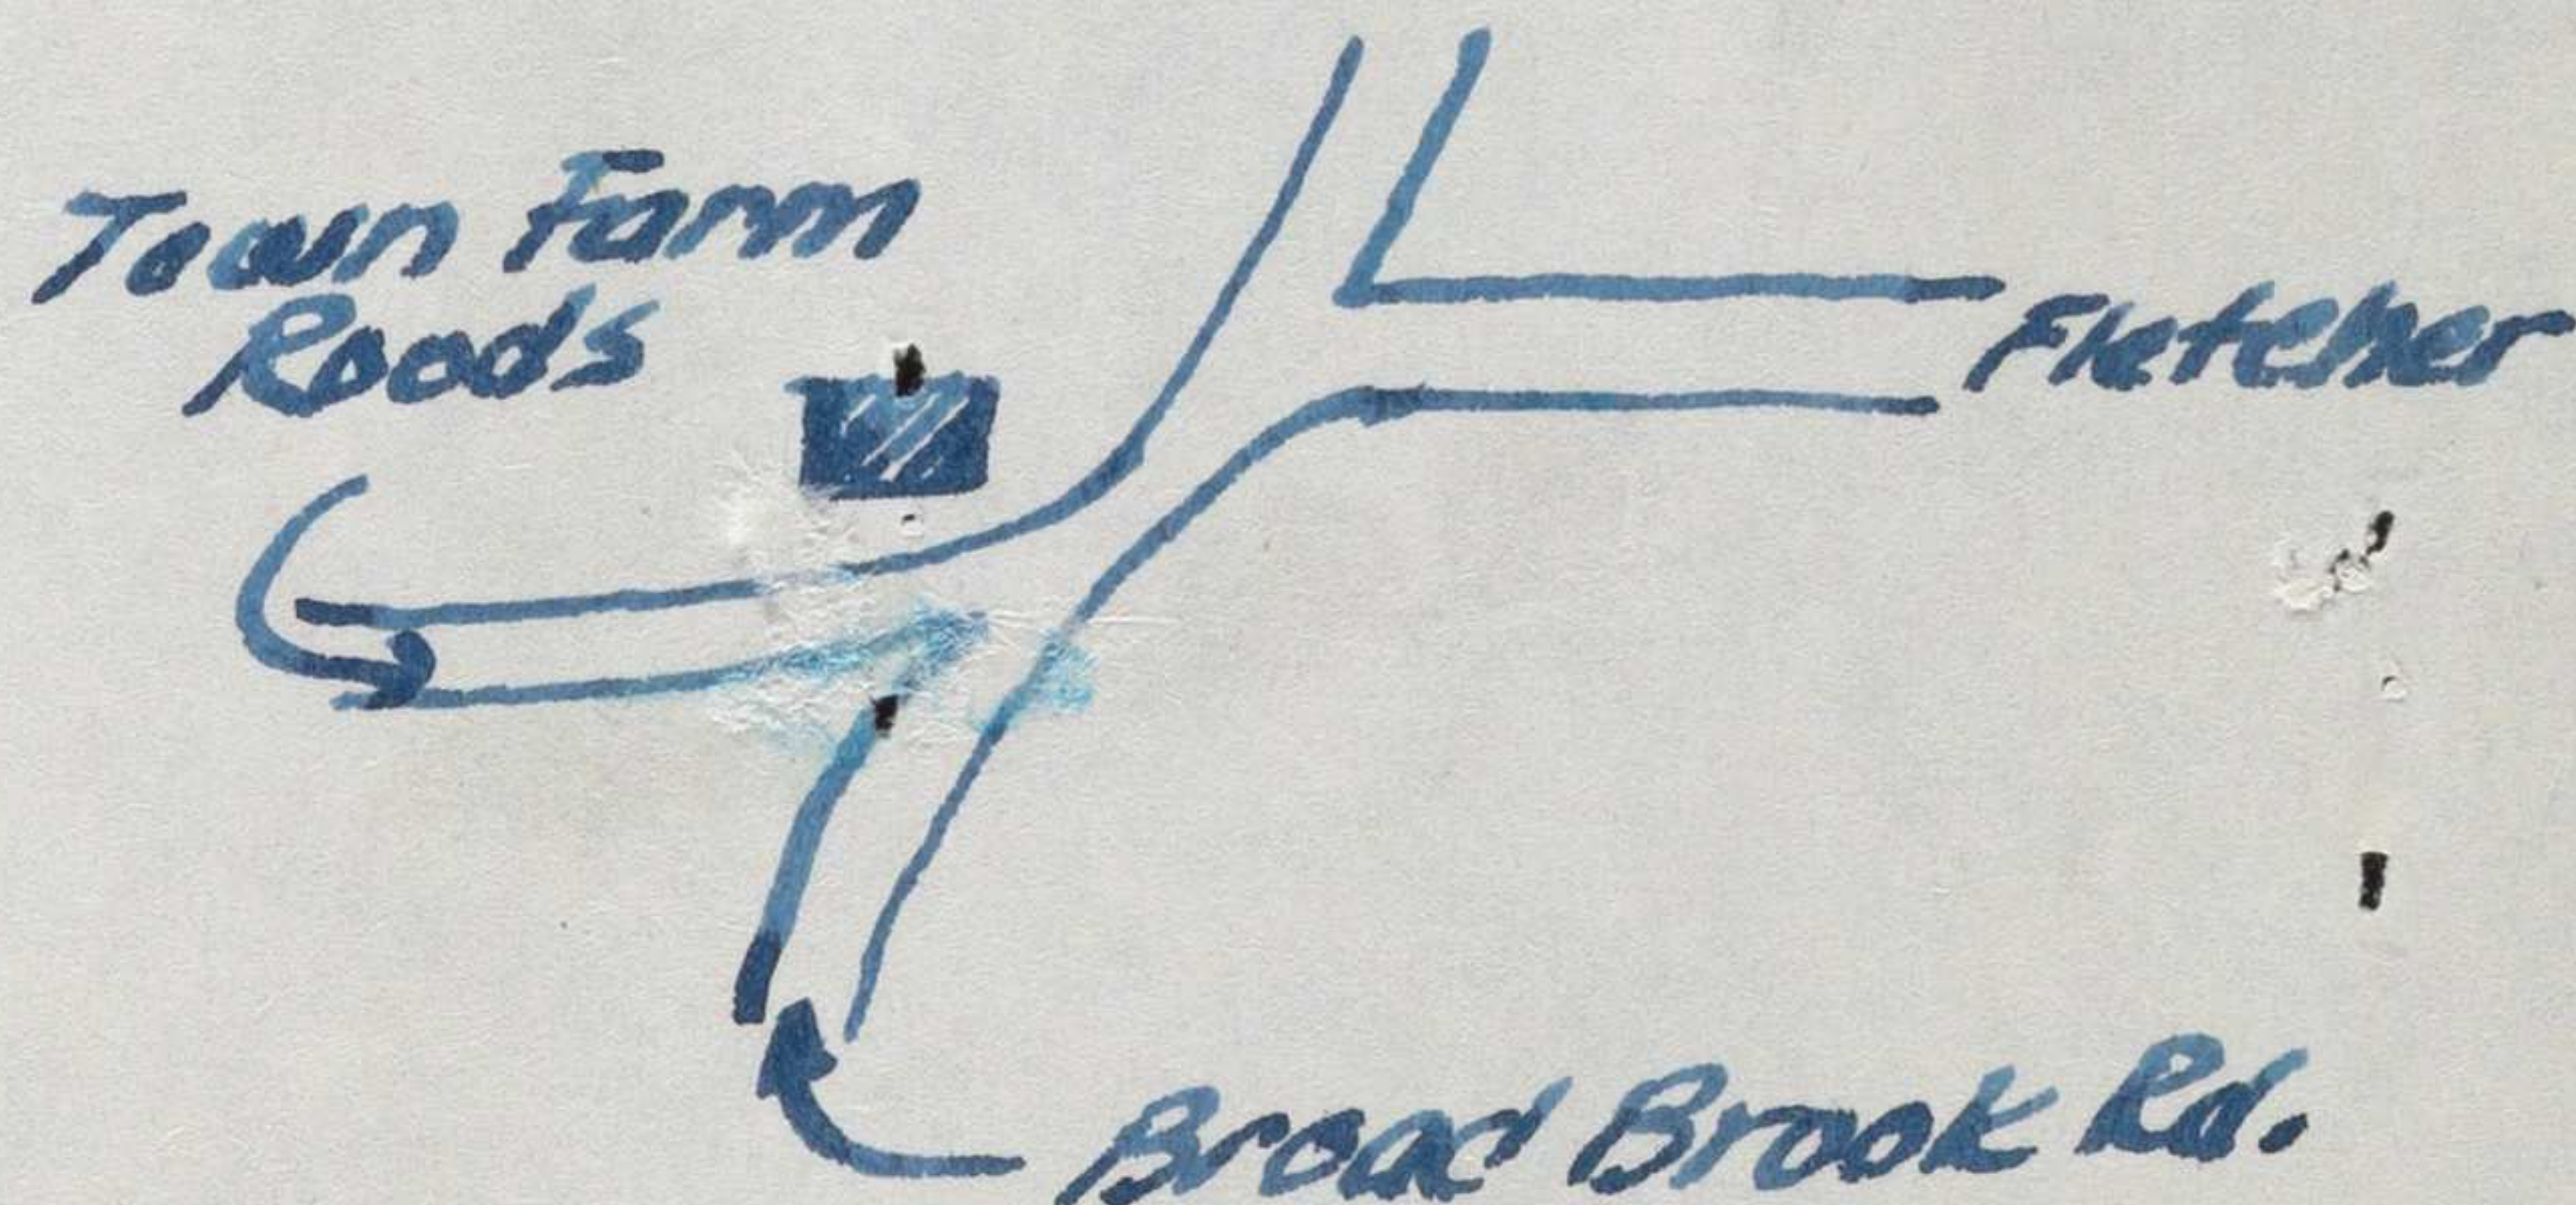
7. PHOTOGRAPH *Enf 43*

Although the core of this farmhouse is quite old there have many to many additions and alterations. The fabric that remains includes a brownstone foundation, five bay facade, shallow pitched roof and central chimney. The dentil work in the cornice is the finest remaining.

Endangered ? Interior *poor* Exterior *poor*

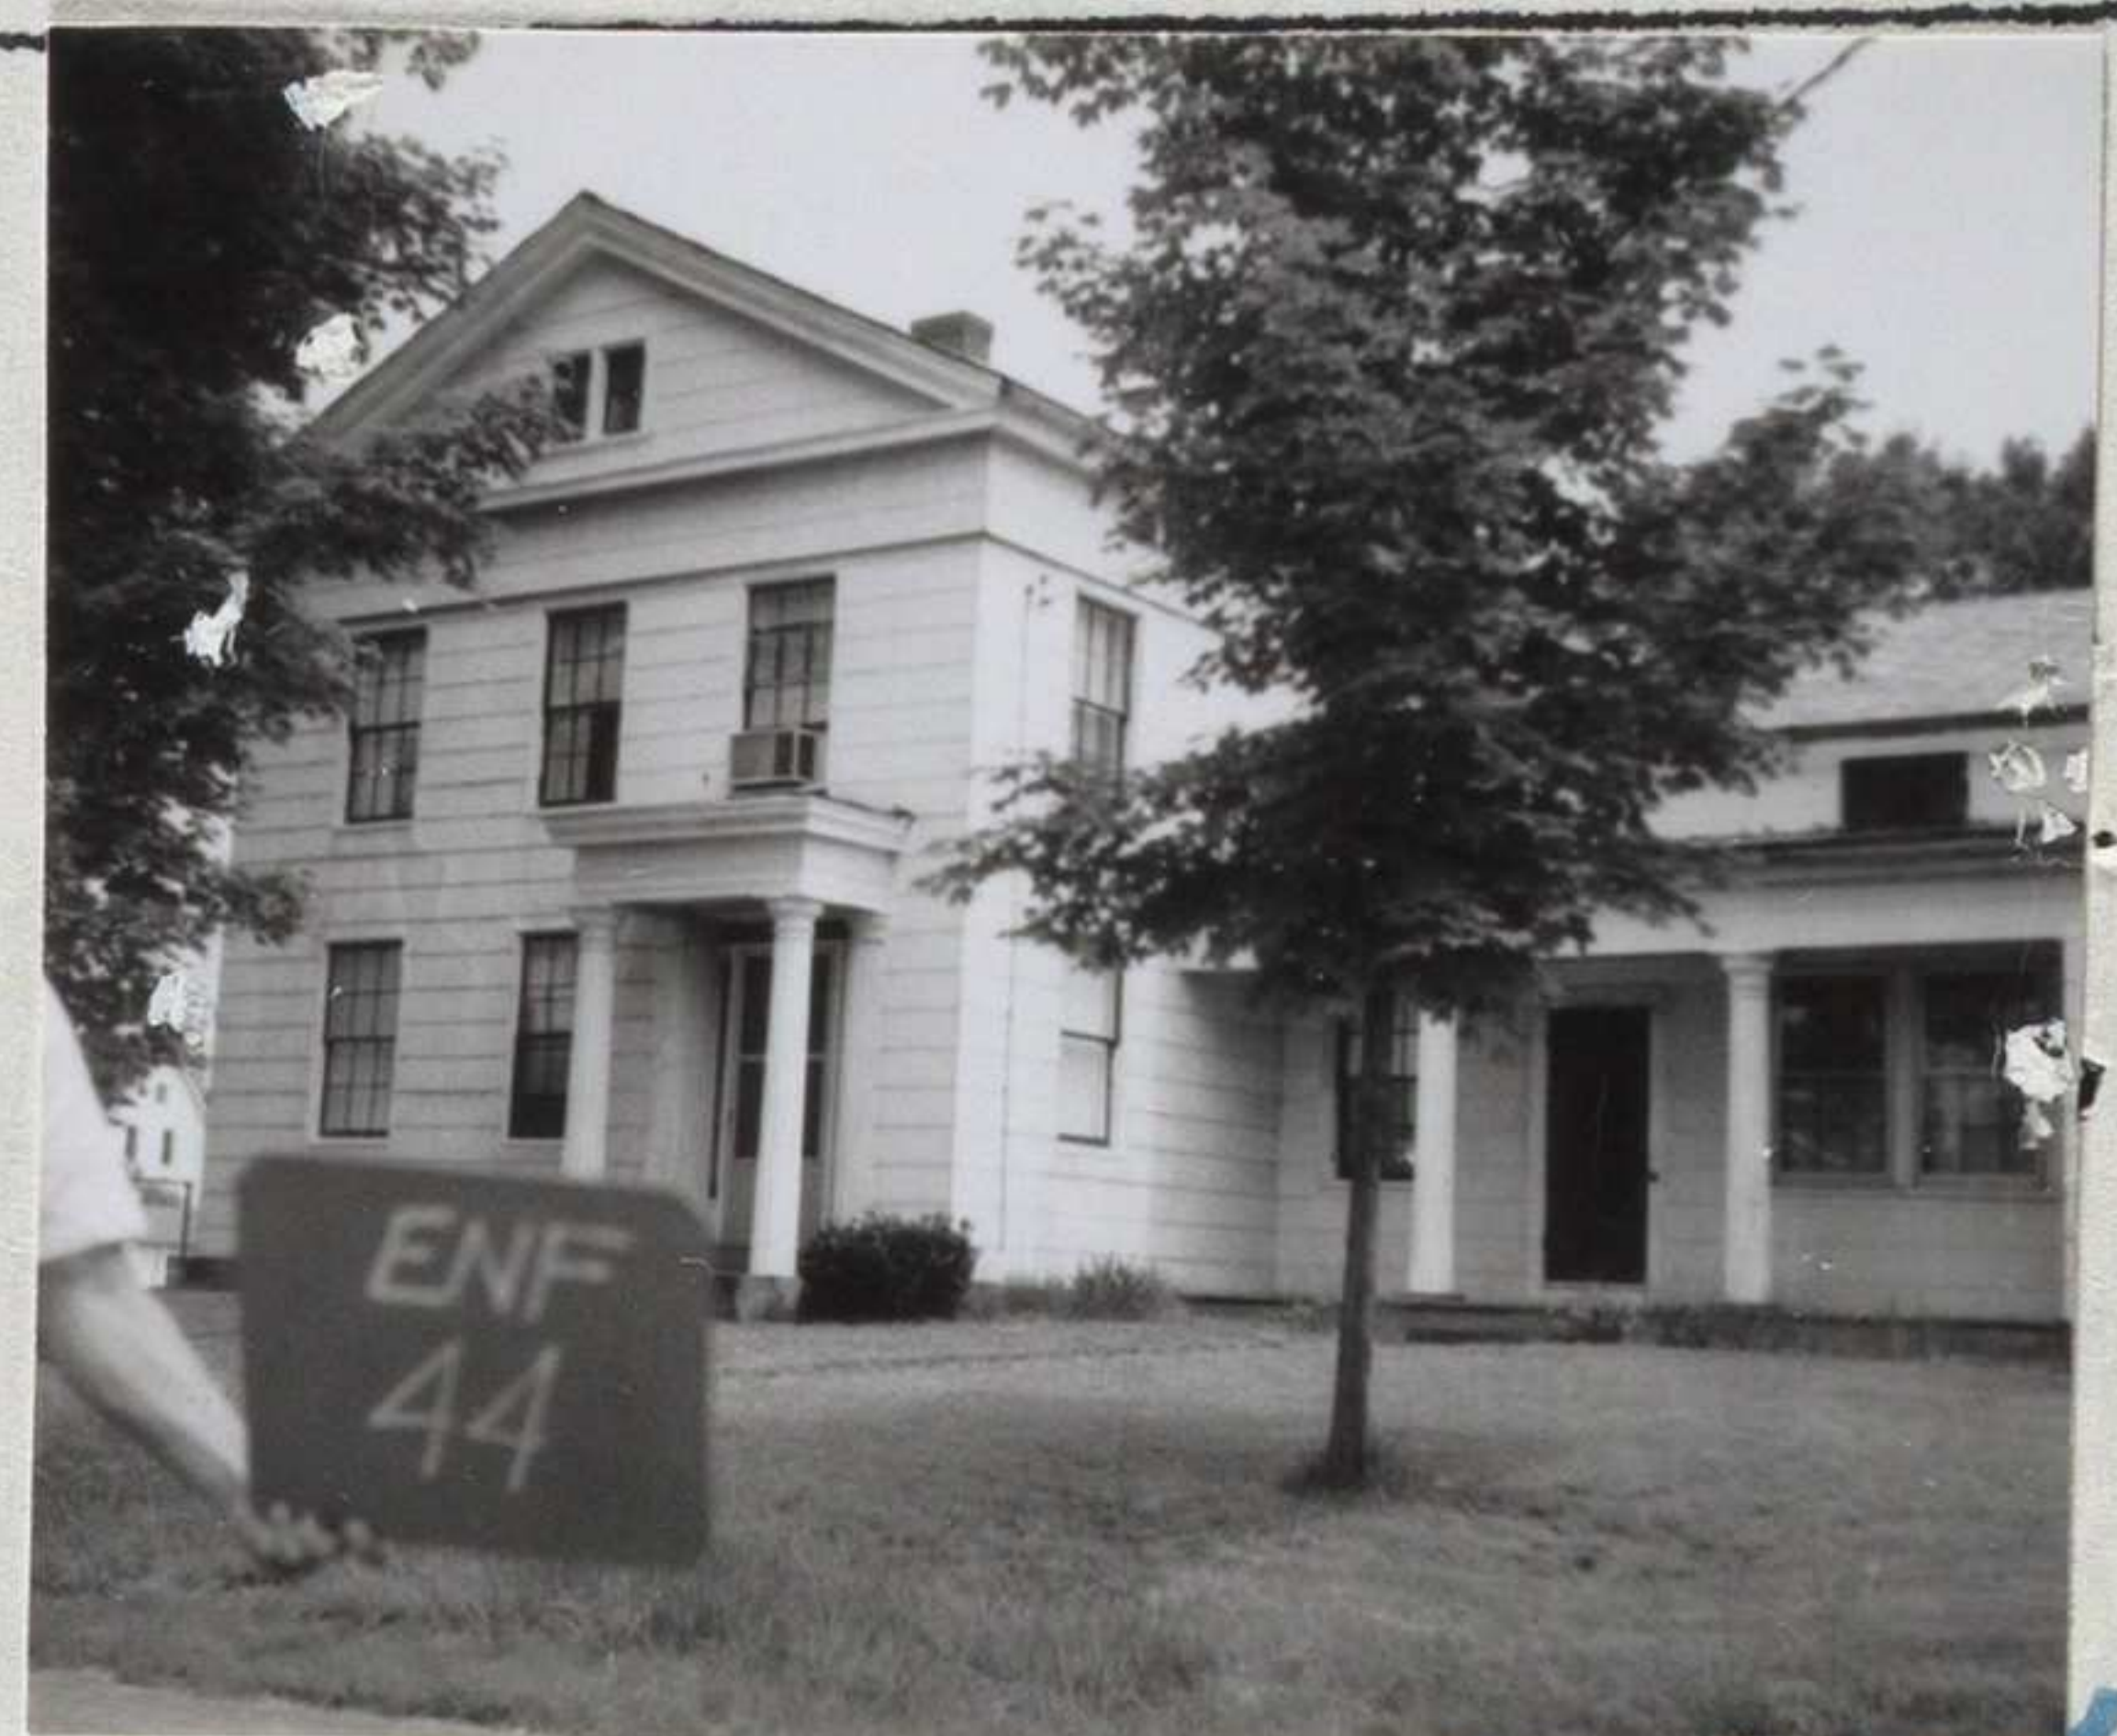
7. PHOTOGRAPH *Enf 44*

This badly altered house has some very fine original features. The brownstone foundations supports main three bay facade and 1 1/2 story side ell. Each section is roofed with a shallow pitch and accentuated pediment with rectangular window. The nicest features of the house are its portico and side porch with Greek doric columns and plain entablature.

5. PHYSICAL CONDITION OF STRUCTURE Endangered ? Interior *poor?* Exterior *poor*

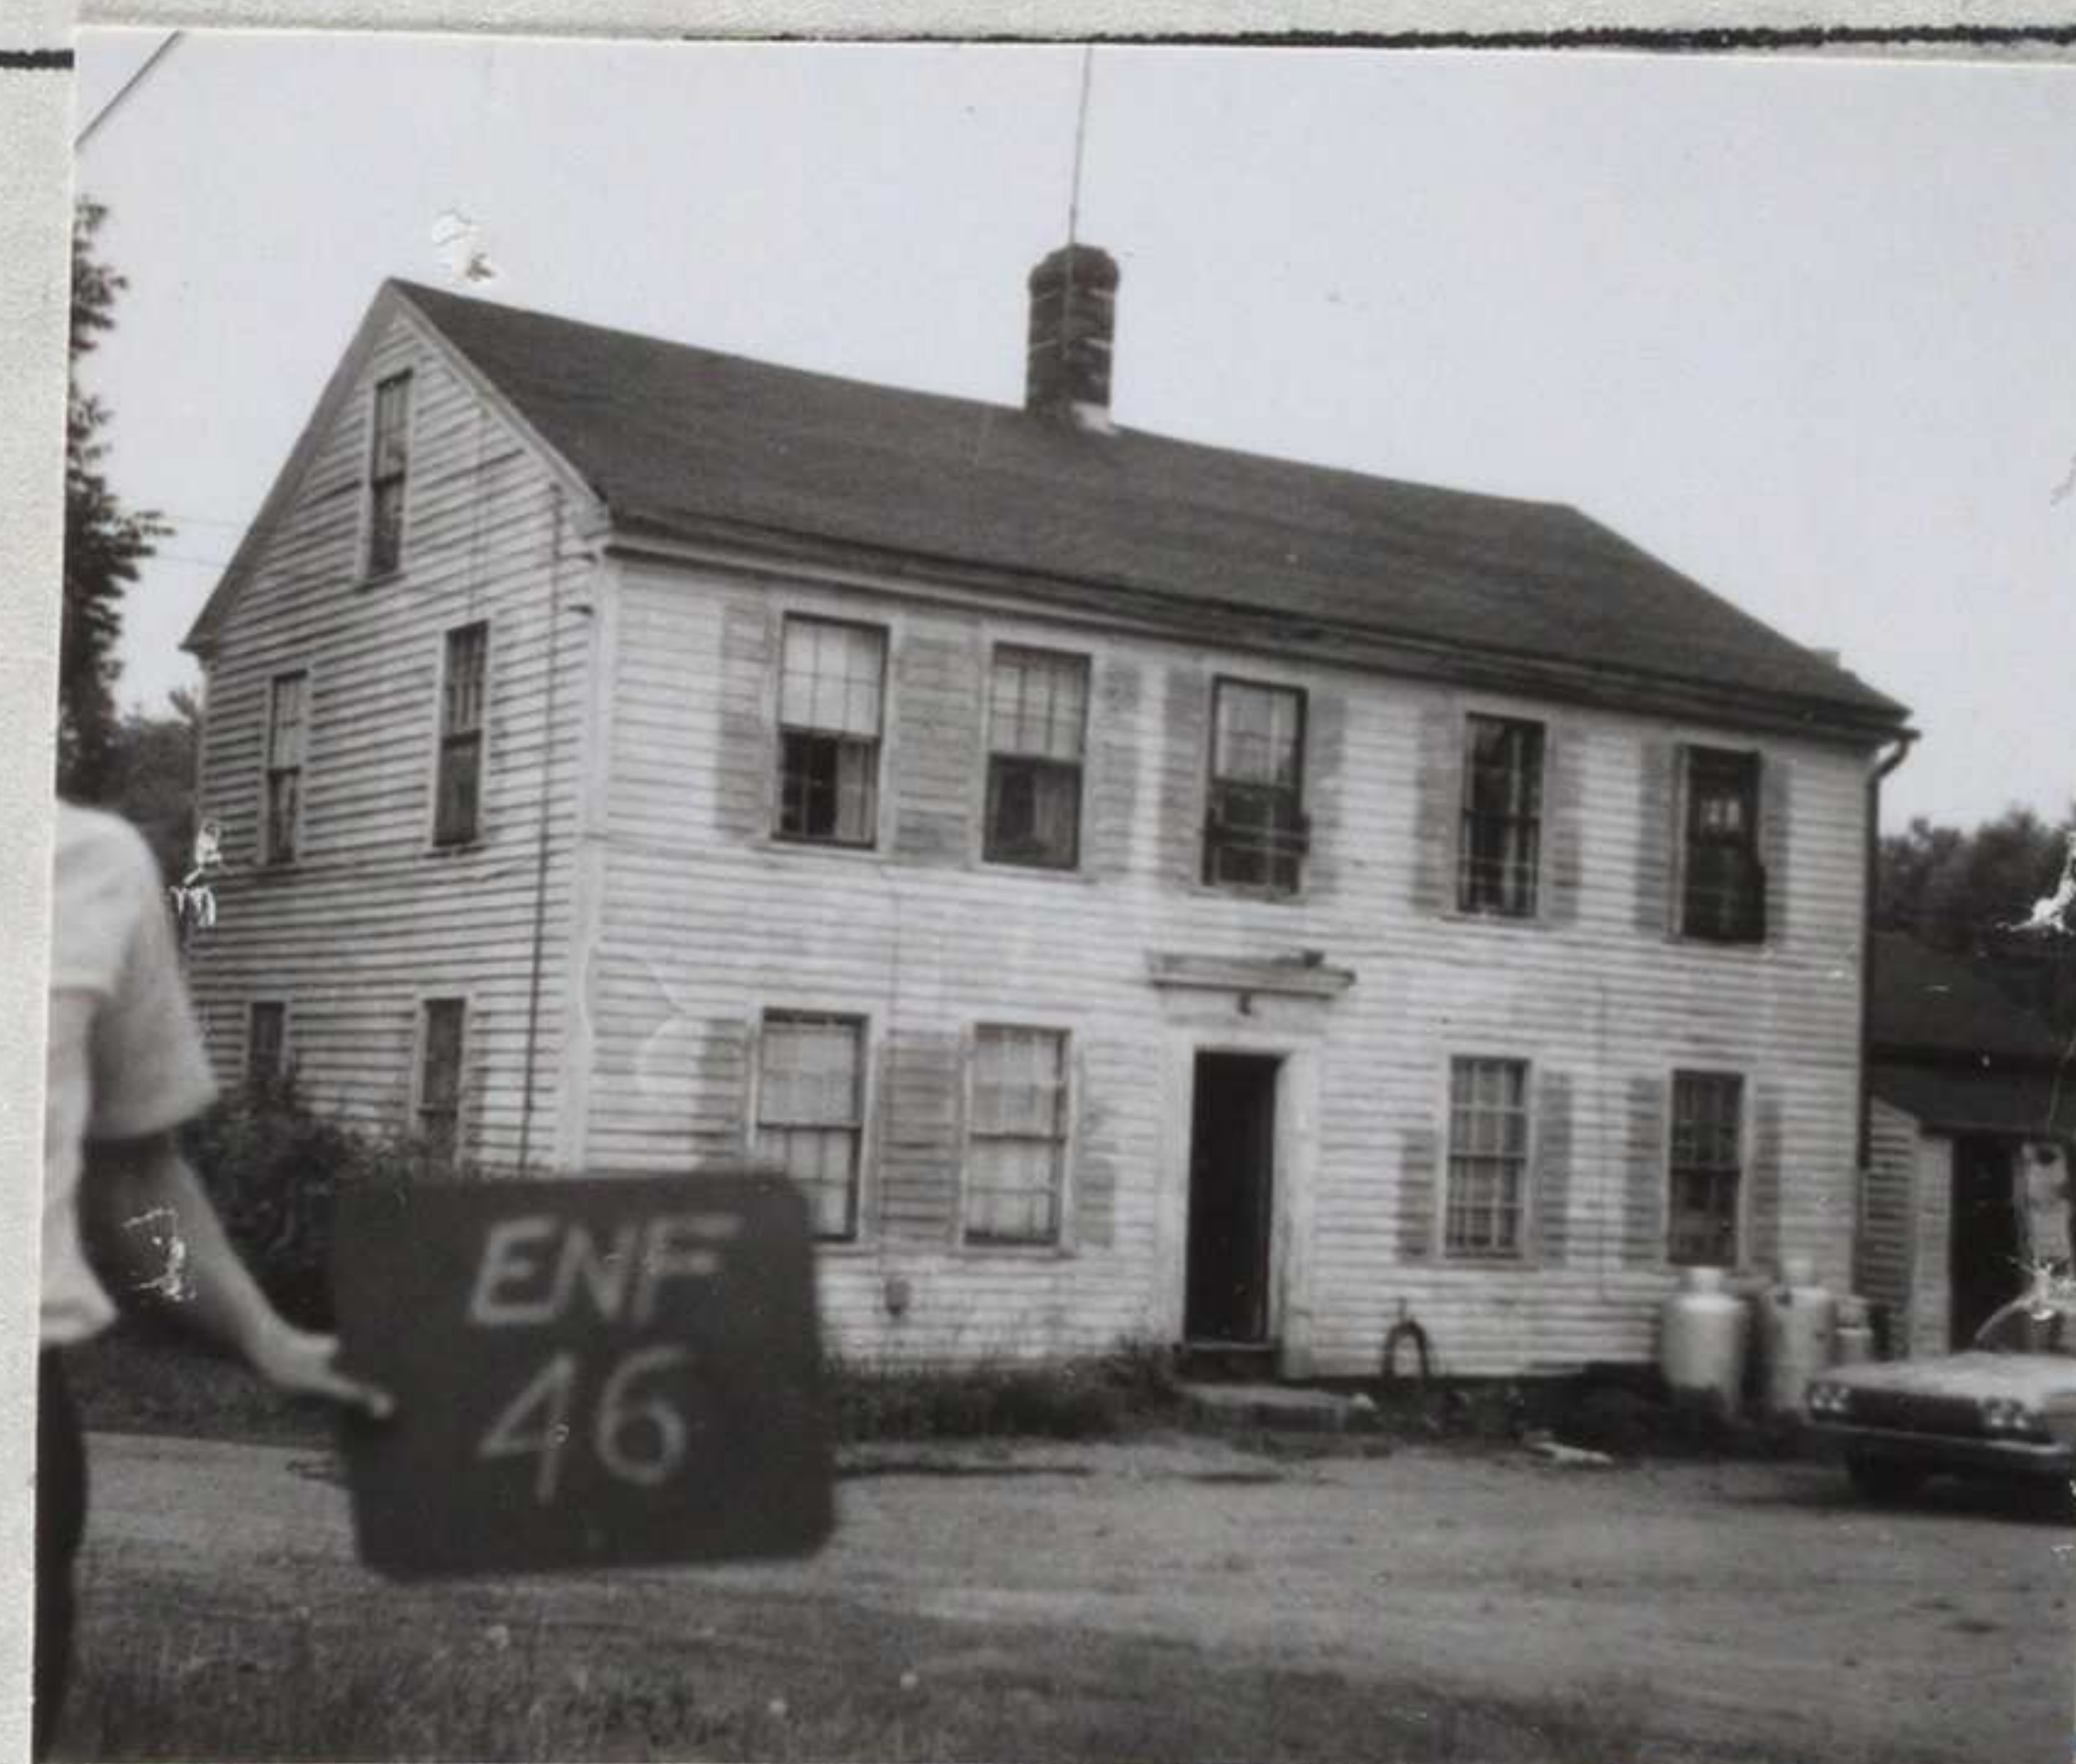
7. PHOTOGRAPH *ENF 46*

*This an old farm house in desperate need
of repair. Due to its brick foundation and location
outside of town it may very well have been
moved. It is in five bays with a shallow pitched
roof and central chimney. The windows are 6/6
construction and the door is simple but original.*

Endangered ? Interior *poor* Exterior *poor*
